# Optimizing Volar Tilt Restoration and Plate Position in Distal Radius Fractures

Kristen M. Sochol, MD, MS,\*† Matthew Gluck, MS,\* Joshua McGough, MS,\* Michael Hausman, MD\*

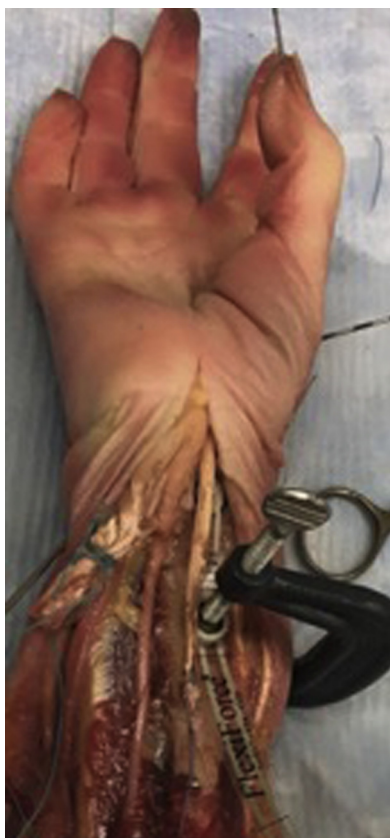
**FIGURE 1:** Experimental setup photograph.

The FPL tendon was transected at the musculotendinous junction, and No.2 Orthocord (DePuy Synthes, MiTek Sports Medicine) was attached to the proximal end of the tendon using a Krackow stitch to allow for the attachment of weights. The other flexor tendons and pronator quadratus muscle were reflected away from the radius to allow for direct placement of the sensor and volar plate (Fig. 1). Two eyelet screws

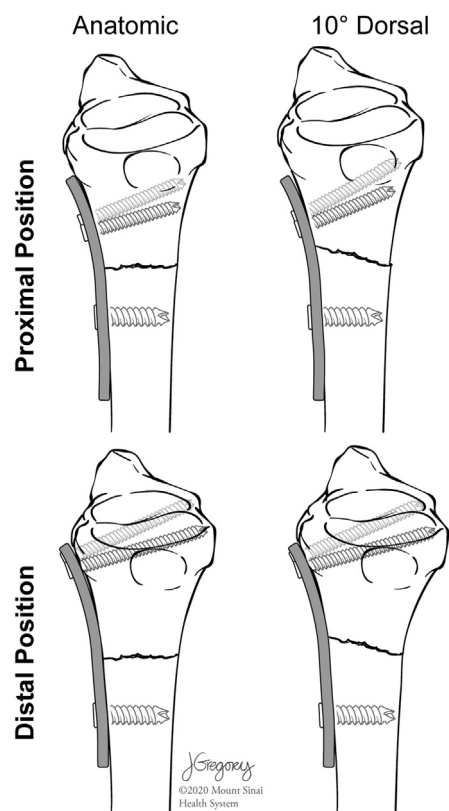
FIGURE 4: Testing conditions.

After the osteotomy, the remaining 4 conditions were defined by volar plate fixation with differing combinations of plate position and volar tilt. The order of these 4 conditions was randomized. The “anatomic proximal” condition was defined as fixation with a volar plate placed just proximal to the watershed line, with complete restoration of the anatomic volar tilt (i.e., no dorsal angulation). The “anatomic distal” condition consisted of the same fixation and restoration of volar tilt; however, the plate was placed 2 mm distal to the watershed line. The “dorsal proximal” condition consisted of volar plate fixation placed just proximal to the watershed line with 10° of dorsal angulation in the distal fragment of the radius. This condition is approximately 20° from the anatomic distal radius, which is 11° of volar tilt as selected based on the fixed angle of the volar plate used in this study. Finally, the “dorsal distal” condition was defined as fixation with the volar plate placed 2 mm distal to the watershed line in addition to 10° of dorsal angulation in the distal fragment of the radius (Fig. 4).

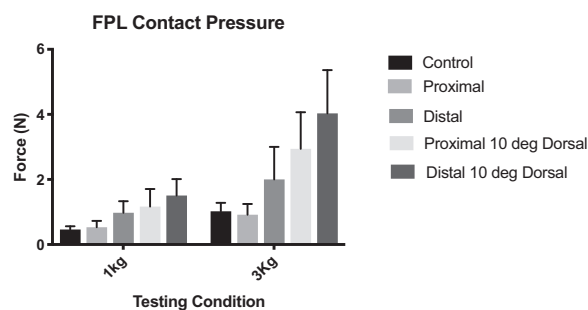
**FIGURE 5:** Flexor pollicis longus tendon contact pressures in testing conditions. Error bars represent 1 SD from the mean.

A significant increase in contact force between the anatomic distal and dorsal distal conditions was observed with a mean increase of 2.03 N ( $P < .05$ ). Significant increases in contact pressure were also observed between the dorsal proximal condition and both anatomic distal and dorsal distal conditions, with mean differences of 0.94 N ( $P < .05$ ) and 1.09 N ( $P < .05$ ), respectively (Fig. 5).
